The Thermo-Mechanical Behavior of the Steam Locomotive Boiler Firebox: An Overall View

Ing. Livio Dante Porta

Edited: Hugh Odom, P.E. & Davidson Ward
Foreword: Ing. Shaun T. McMahon

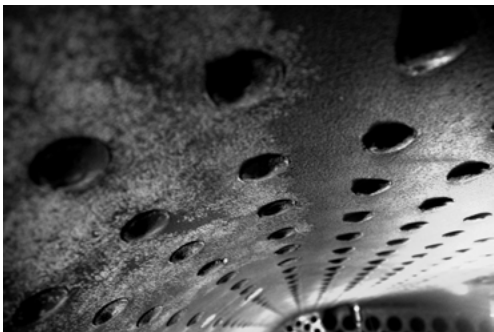
Cover Image - An image of the crown sheet of a mainline, U.S. steam locomotive taken during routine maintenance.

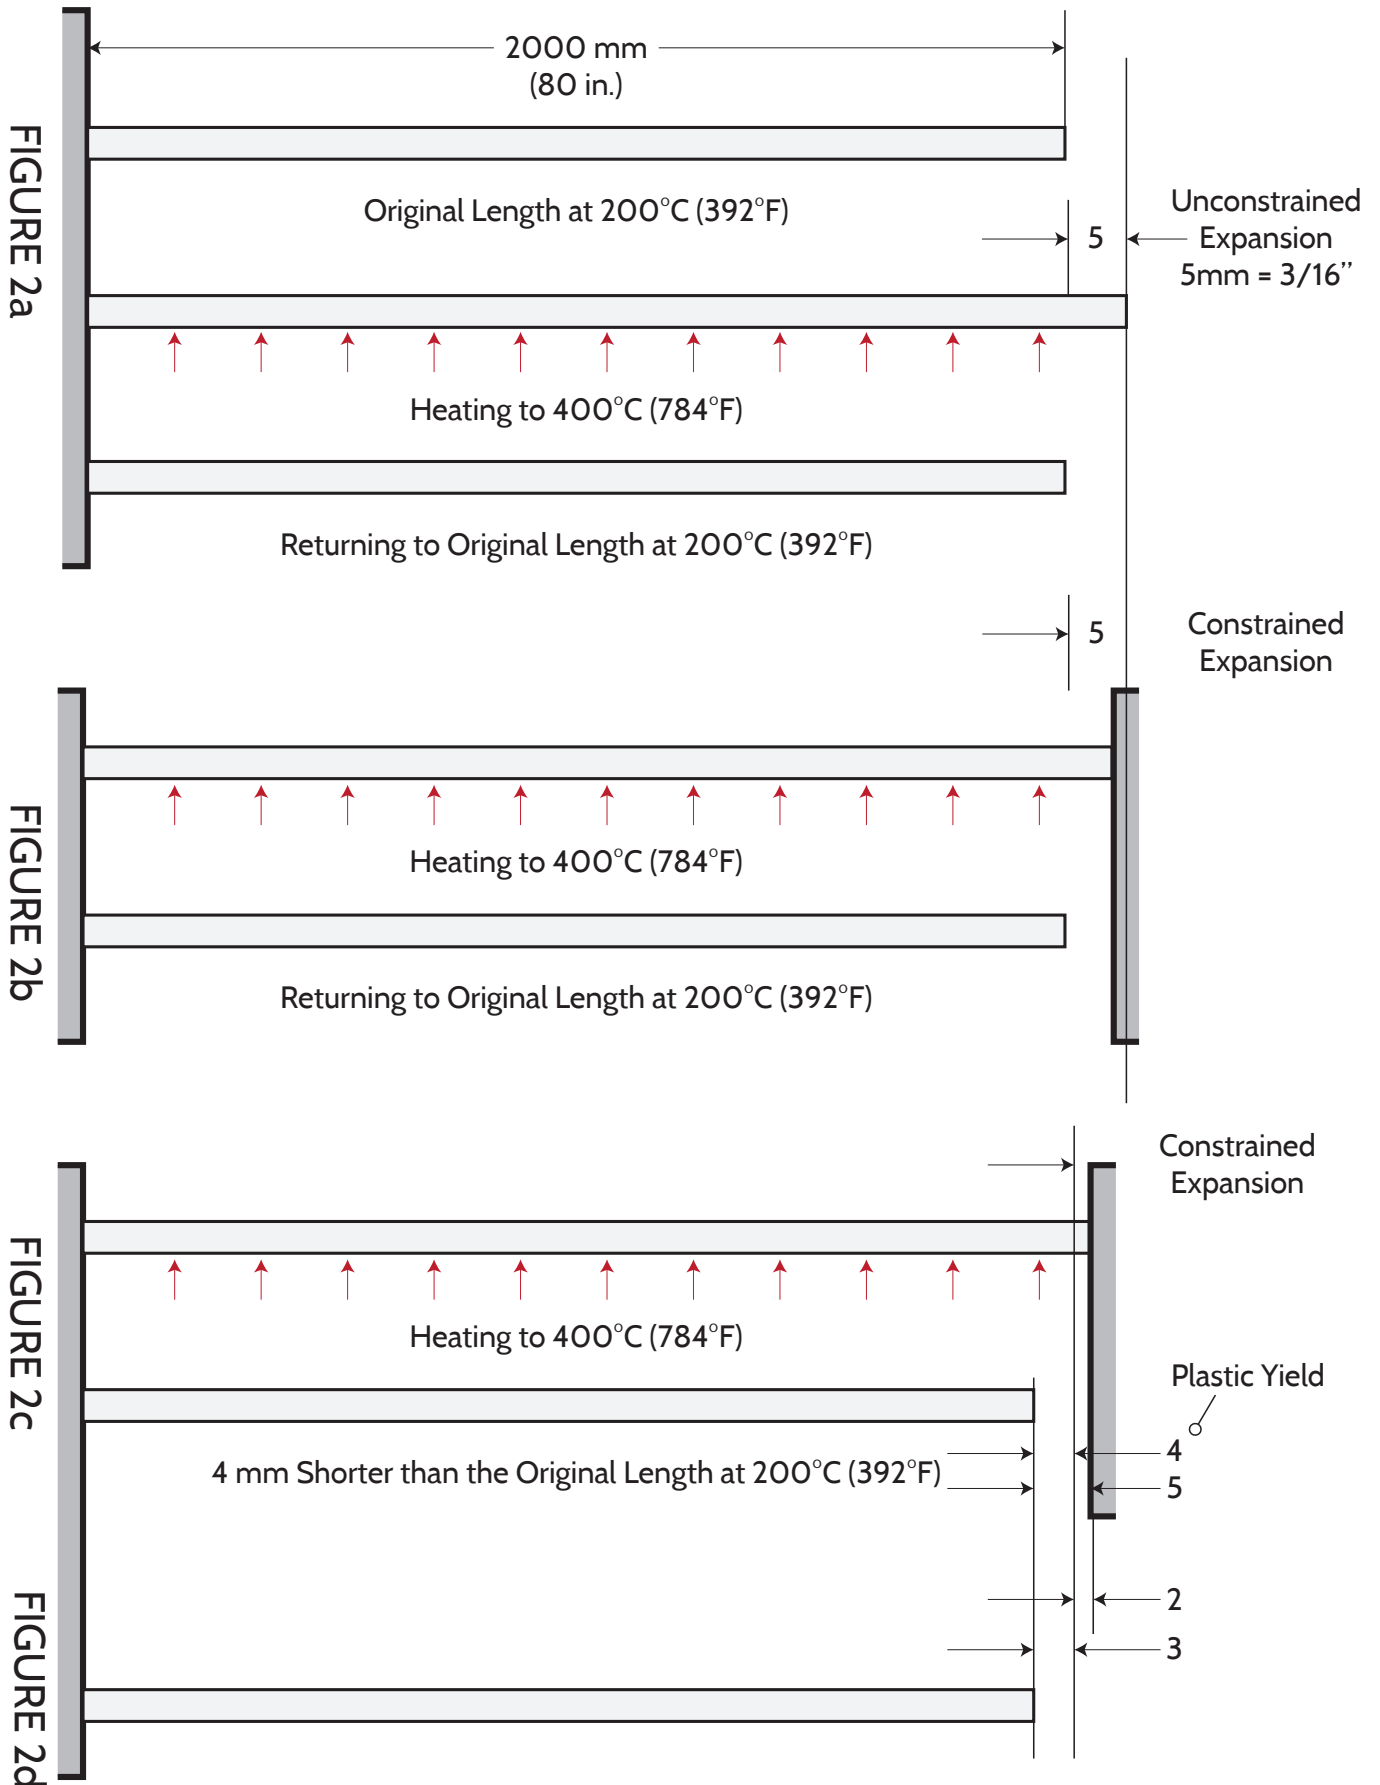
Figures 2a-2d Expansions, strains and stresses occurring in a steel rod upon heating.

With reference to Fig 2, let a 2 m (80 in) steel rod to be uniformly heated from 200°C (392°F) to 400 °C (750°F): it will expand 5mm (3/16 in) if unconstrained (Fig 2a). If the temperature returns to 200°C (392°F), the rod will resume its original length of 2 m (80 in).⁴ If (Fig 2b) the rod is not allowed to expand freely by an obstacle (say limited to 4 mm = 0.016”): compressive stresses result. In this case:

If the expansion is severely constrained, say to only 1 mm, the rod will accommodate itself by plastically yielding the remaining (5-1) = 4 mm. When returning to the starting temperature of 200°C (375°F), it will be 4 mm shorter in length (Fig 2c). Thus, it will show a “squeezed-in,” “shrunk,” compression (Fig 2c). If the heating-cooling cycle is repeated, the rod will play 5mm to and fro, just touching the construction.

If in the cooling half-cycle, the rod is impeded to feely contact more than 2mm (Fig 2D), the remaining 3mm will be absorbed by a plastic stretching, but this time the corresponding yield stress will be that of the 200°C (392°F) temperature, namely:

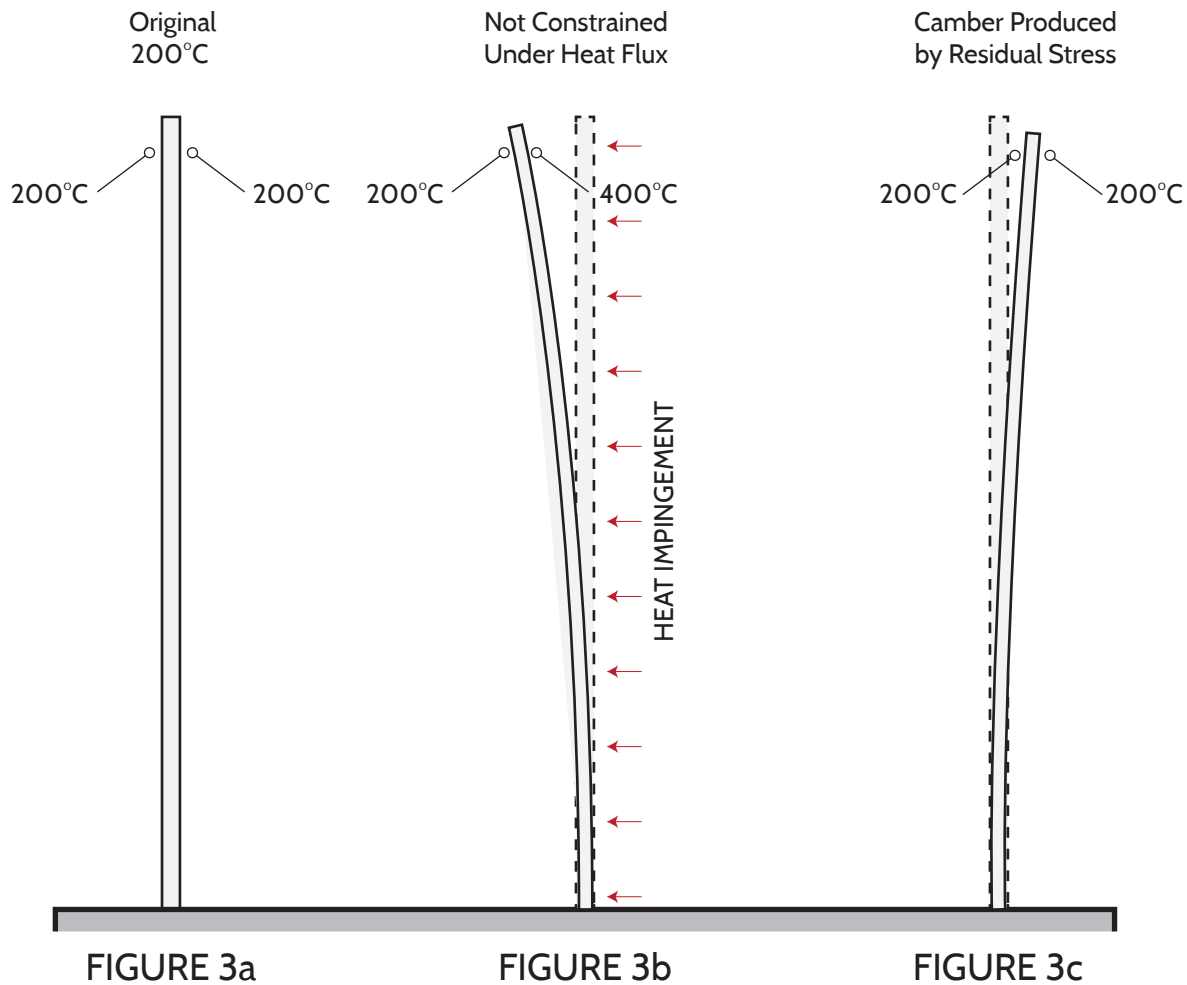
Figures 3a-3c Effect of temperature differences between the faces of a plate subjected to a heat flux.

When a plate is subjected to a heat flux (Fig 3a), the face receiving the heat impingement will be heated up to, say, 400°C, while the other side will keep, say, at 200°C. The plate will expand lengthwise, but also will bend because of the longer length of the expanded hot fibers as compared to the unexpanded cooler fibers (Fig 3b). When the heat flux ceases, the temperature of both faces will equalize and the plate will return to its original plane condition.

Should the plate be constrained to keep plane, compressive stresses develop in the hotter side and tensile stresses on the cooler side. If the temperature difference between both sides keeps within the limits,

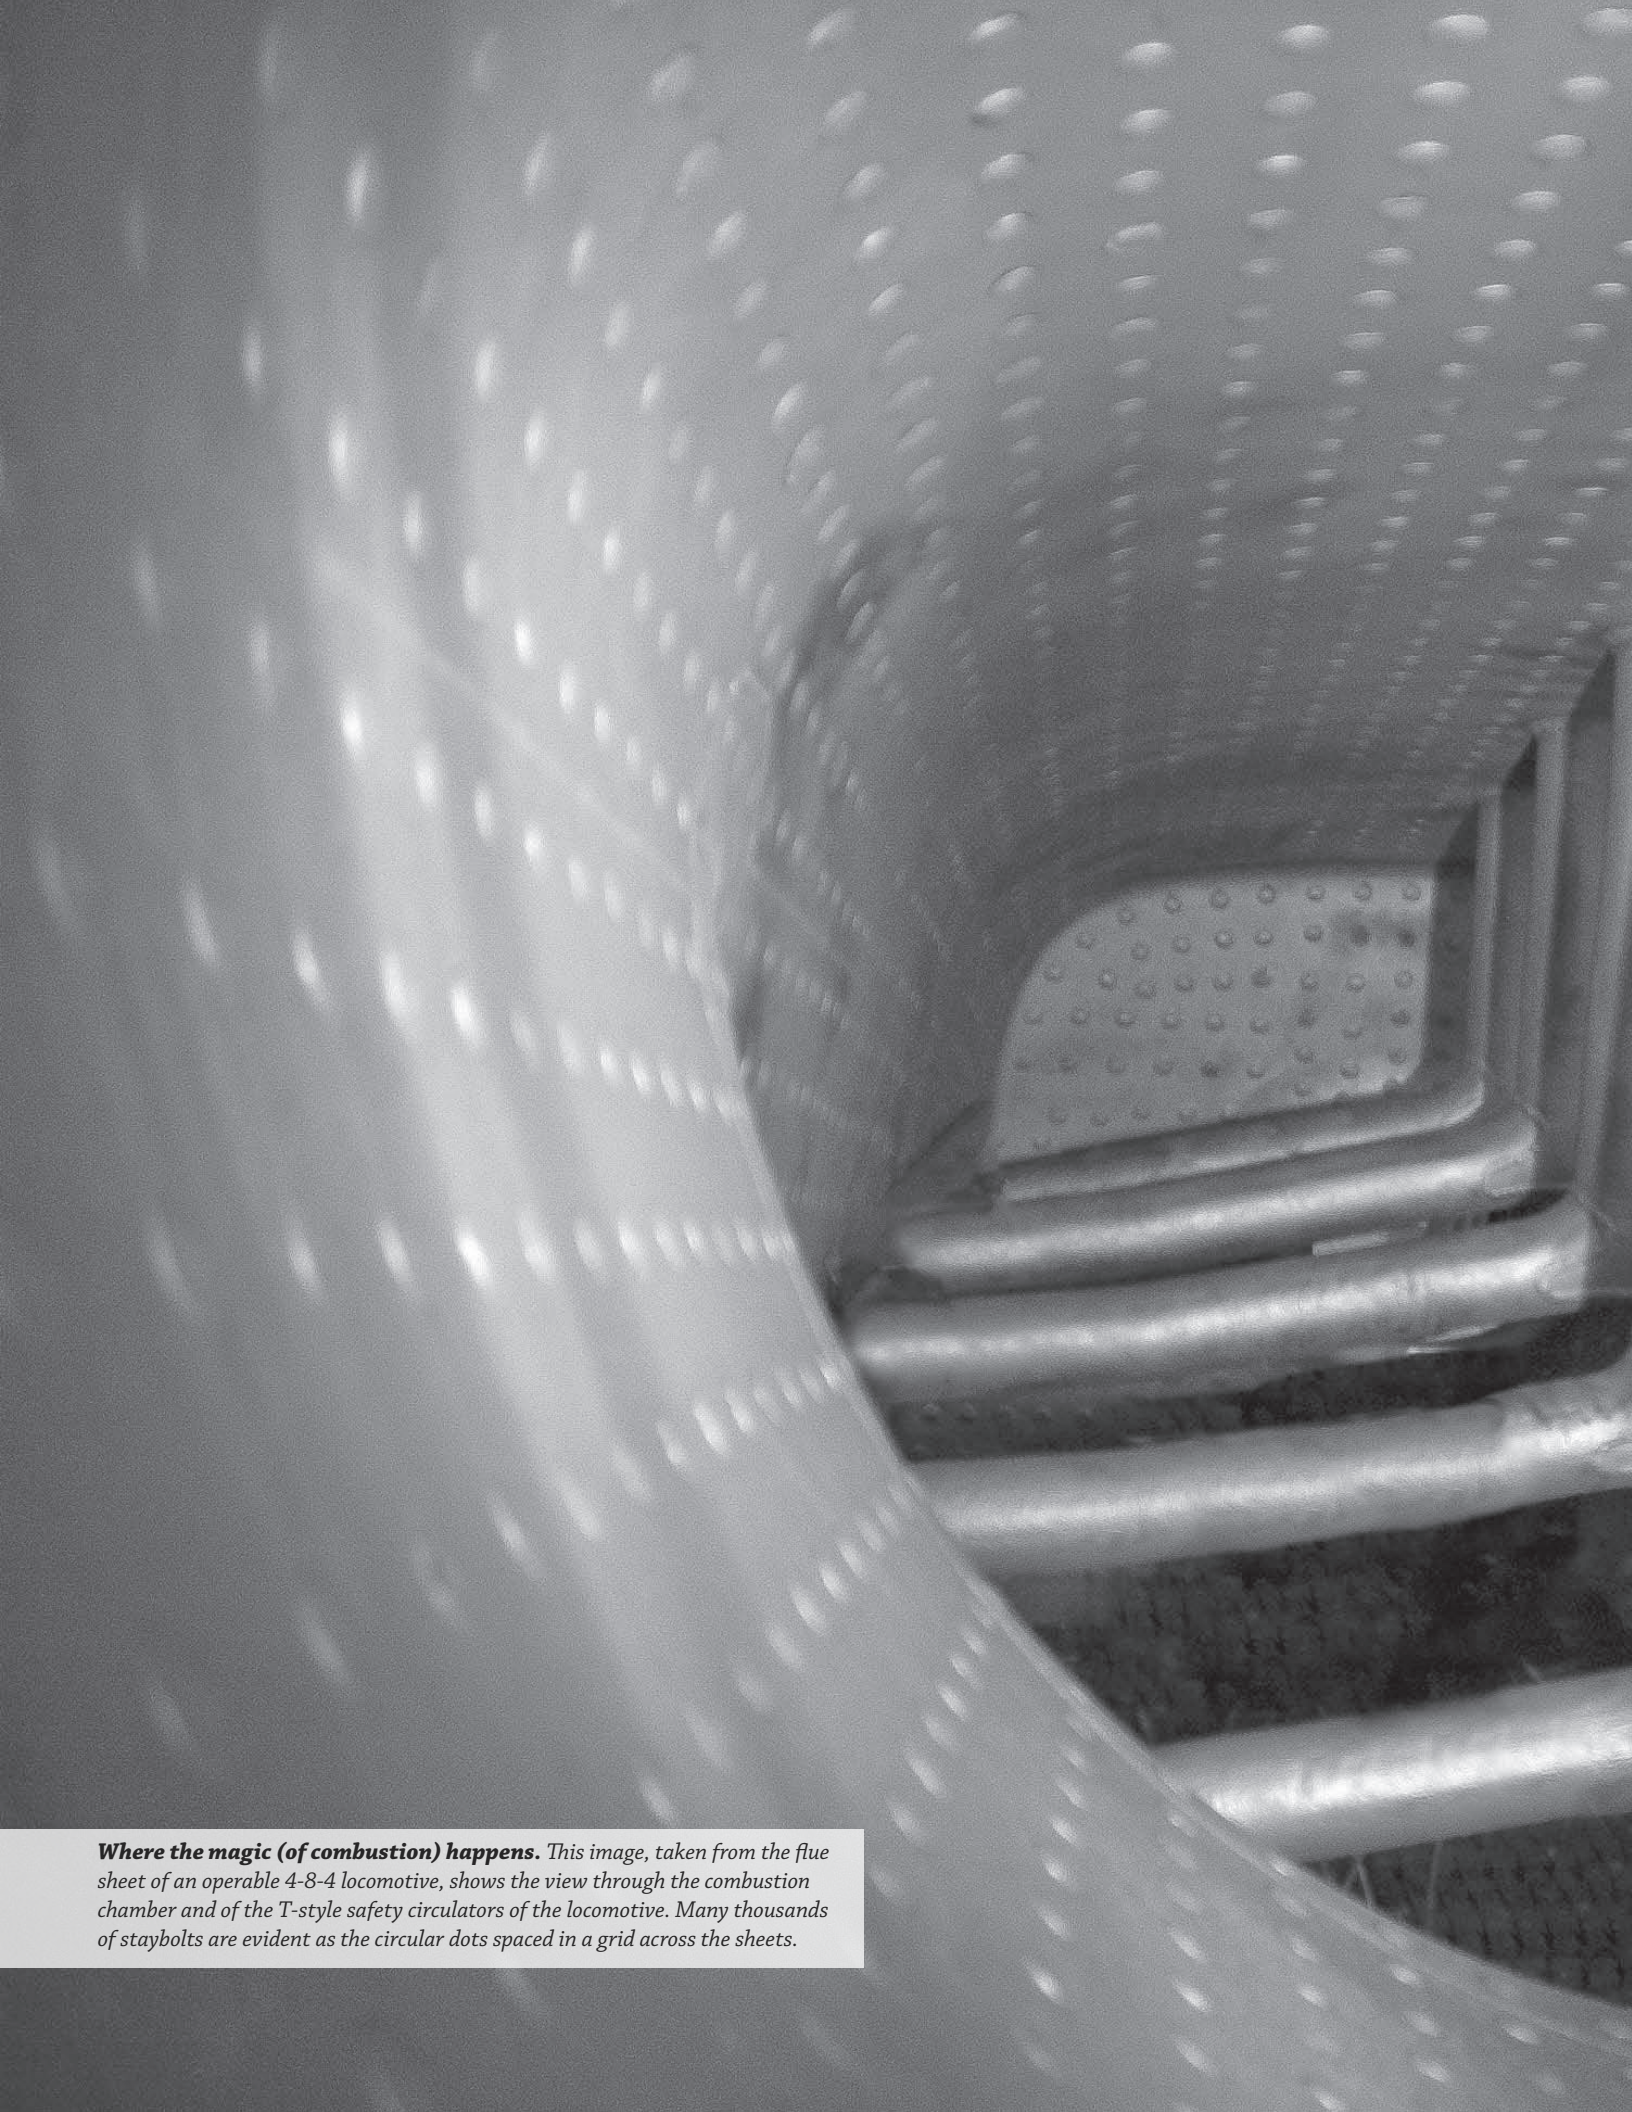
Where the magic (of combustion) happens. This image, taken from the flue sheet of an operable 4-8-4 locomotive, shows the view through the combustion chamber and of the T-style safety circulators of the locomotive. Many thousands of staybolts are evident as the circular dots spaced in a grid across the sheets.

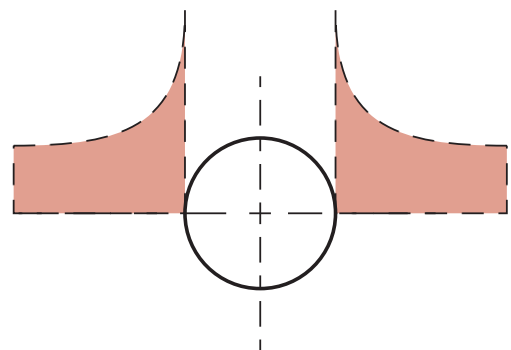
FIGURE 5

Figure 5 Tensile stress concentration around the stayhole

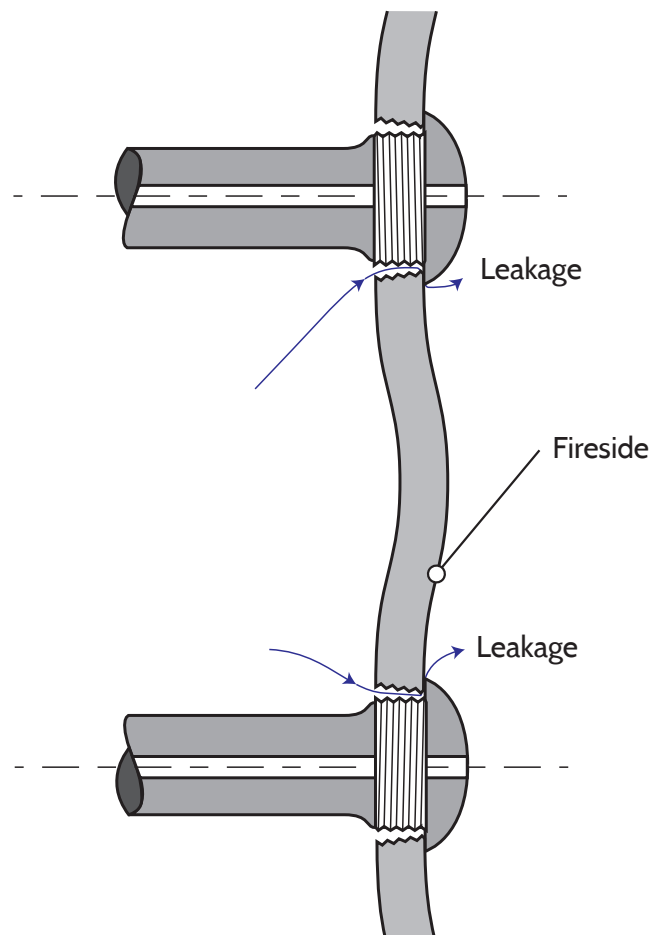
Figure 6 Stay leakage produced by large bulging (not to scale)

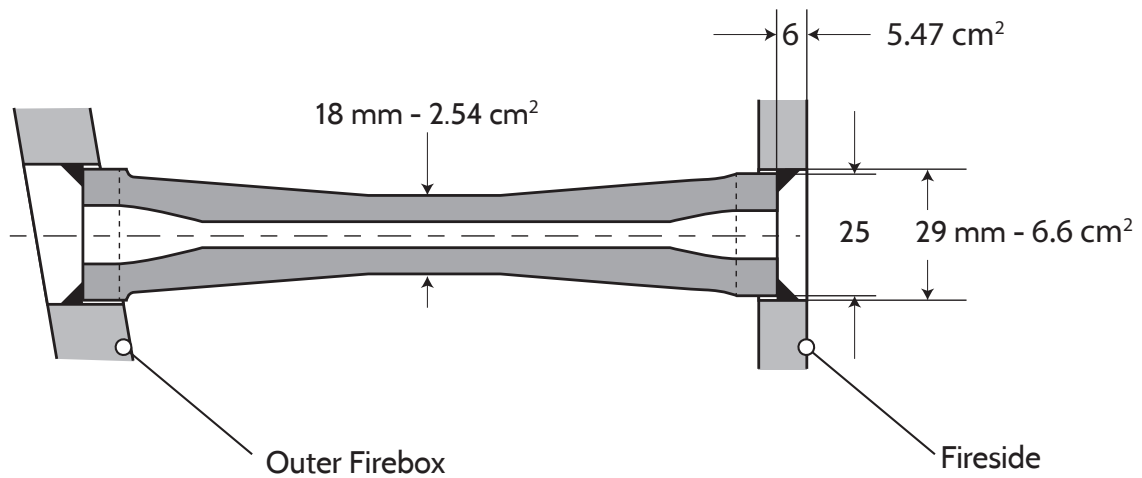
FIGURE 10

Figure 10 Latest form of stayhead proposed by TROSS.
